# TROY HILL VACANT

## TROY HILL, PITTSBURGH 2011

# LAND ASSESSMENT

This 2011 report was produced by GTECH Strategies (Growth Through Energy and Community Health) for the Troy Hill Citizens Inc. This plan was financed with a grant from the City of Pittsburgh through the Community Development Block Grant (CDBG) Program, Luke Ravenstahl, Mayor.

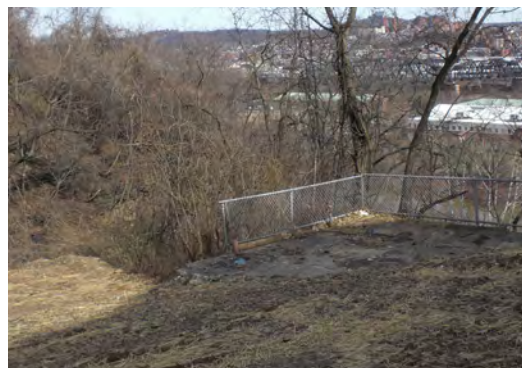
*Above: Elbow Street Contiguous Lot*

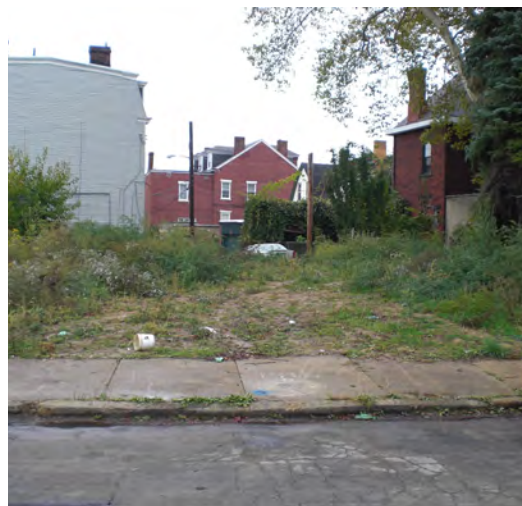
*Above: Gardener Street Contiguous Lot*

Across from the Gardener Street ball field lays two vacant lots. Their condition is less than ideal. One appears to have been used as a parking lot. At the community meeting, neighbors voiced their concerns over the lack of care of this site.

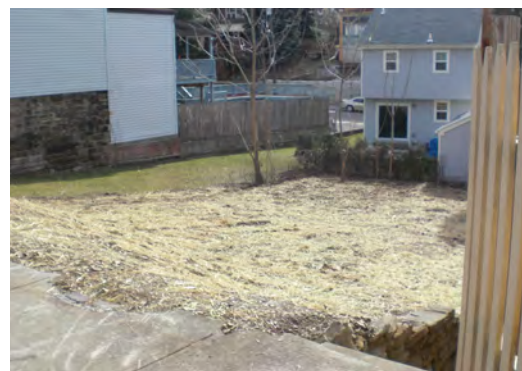
*Above: Rialto Street Contiguous Lot*

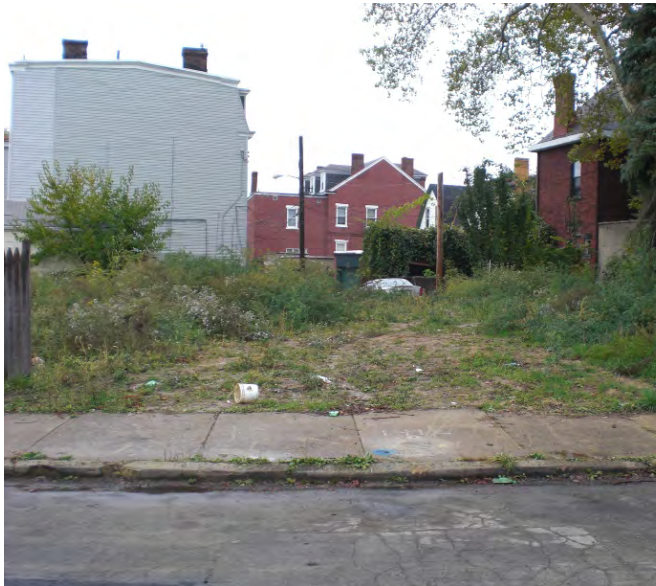
*The site is currently used as a cut through*

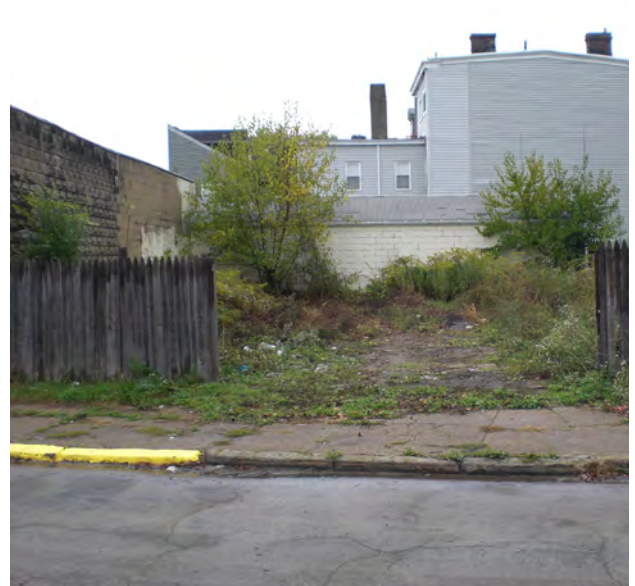
*The site is often overgrown and unkept*

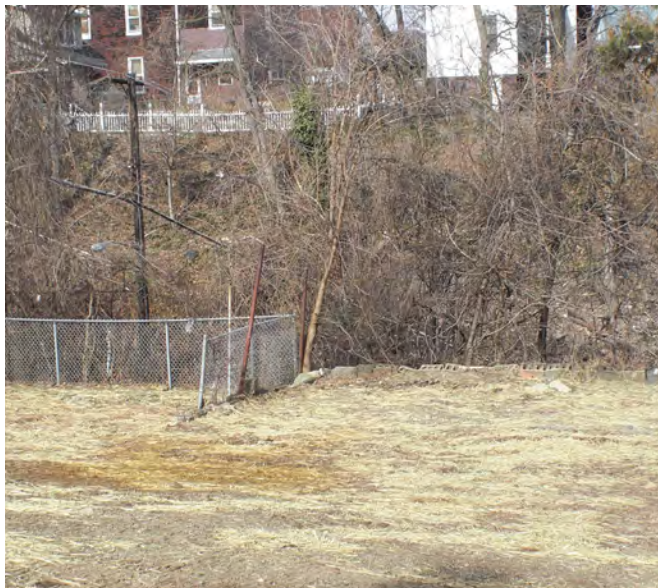
*The site after demolition*

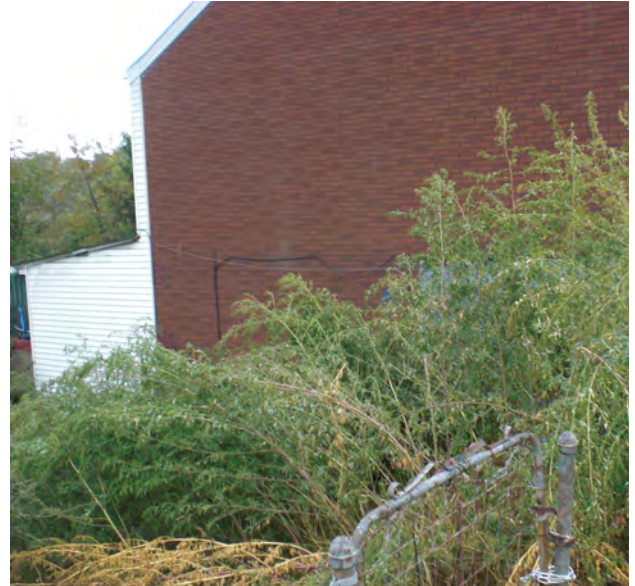
*The unkept portion of the site*

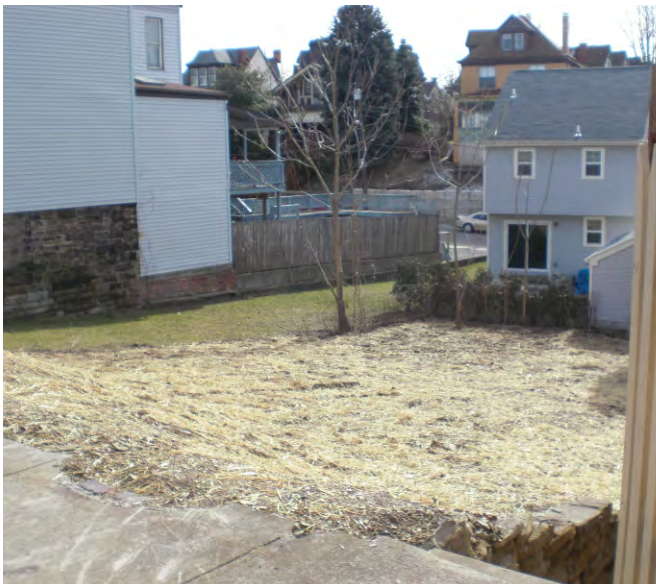
*The site after demolition*

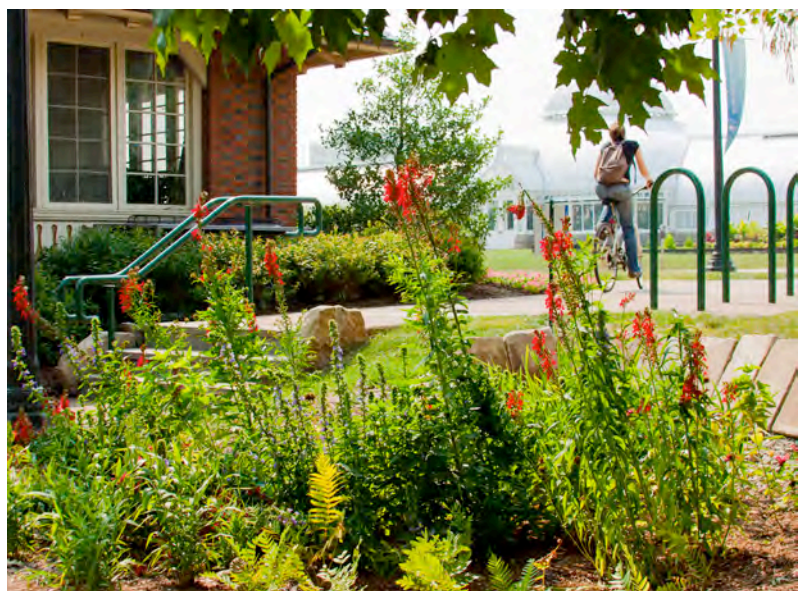
A rain garden is an attractive strategy that reduces stormwater runoff before it enters the sewer system. Rain gardens can vary drastically in cost, depending on how extensive the design is. The simplest rain garden installation using volunteer labor can cost as little as \$4,000 for a demonstration site of 400-500 square feet. More engineered features and hiring contractors for installation can drastically increase the cost. Given the cost associated with installation, this can be considered either a short or long-term strategy.

*A public rain garden outside of Schenley Visitors Center, in Schenley Park.  
Photo courtesy of the Pittsburgh Parks Conservancy.*

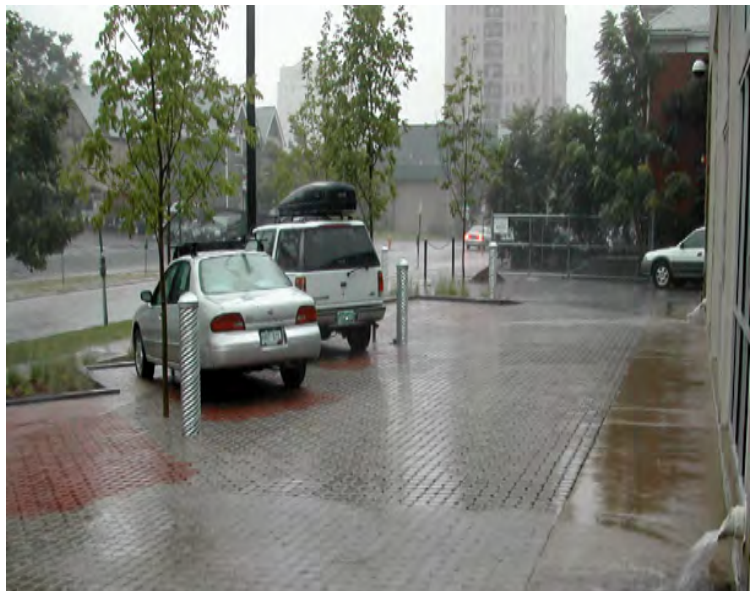
Permeable Pavement is a material that allows rainwater to be absorbed through the surface, reducing runoff and strain on the sewer system. Planting trees and other vegetation around the edges allows for more rainwater catchment, in addition to the beautification of the site.

*A porous paver parking lot absorbing roof runoff. Photo courtesy of Wenk Associates.*

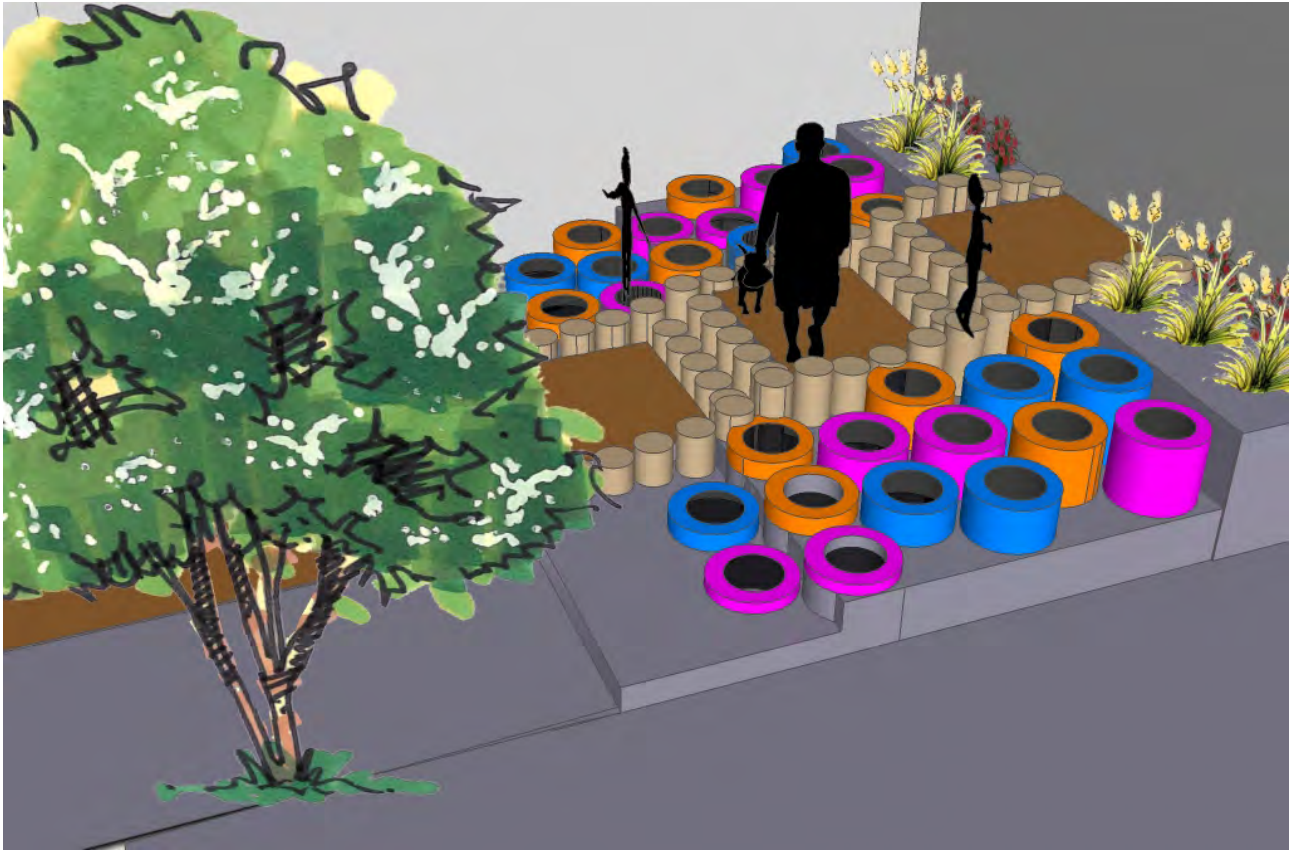
*Elements of the Straubs Lane site include “stairs” designed from tree stumps and tires. Landscaping at the top will include low-maintenance native perennials.*

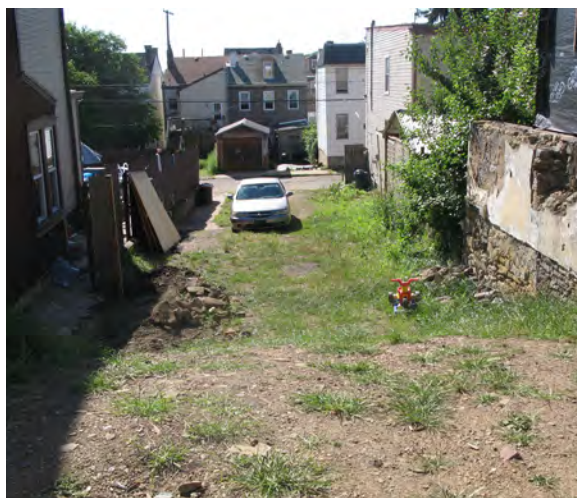
Citizens had expressed concern about a vacant lot on Straub Lane being used for illegal parking and disruptive behaviors to neighbors. GTECH and Troy Hill Citizens evaluated this site, met with neighbors and presented the site plan to the right. The site is currently being used as a cut through and the design will include solar lighting, painted tires to stabilize the hillside, a defined pathway lined with small trees, perennial shrubs and flowers. This low-maintenance design will provide a safe space for neighborhood youth to play off the busy streets of Troy Hill.

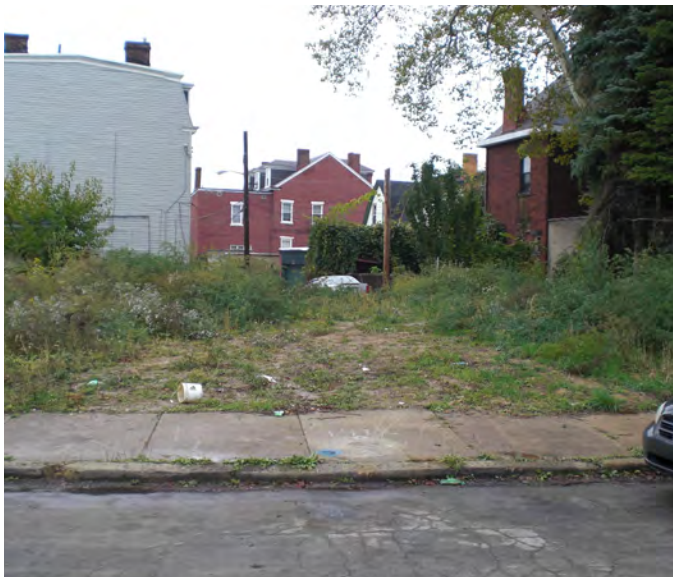
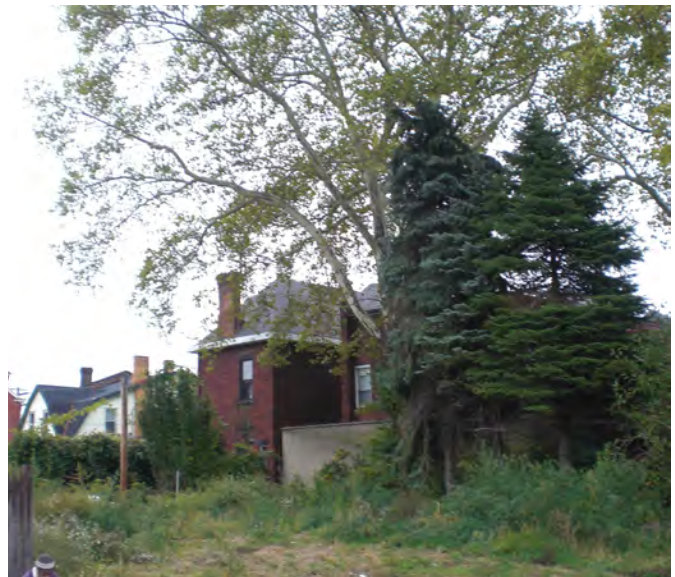
Owner: Joseph M. Senoski		Lot/Block #: 24-D-114		Address: 1412 Gardner	
Summary of site condition:		Easily accessible, flat site with good sun exposure. Compaction and invasives are not a problem. With owner permission, this site could provide an excellent, centrally located space for a community project.			
Organic Matter:		Low	Soil Contamination:		Low lead
Soil Structure:		Sand/clay	Compaction:		4" – compacted/normal
Rubble Type:		None visible	Dumping (1-10):		1 – none/low
Percentage:		N/A	Littering (1-10):		6 - medium
Slope (1-10):		1 – none/slight	% Sun:		80%
			Canopy:		Large trees
Vegetation Coverage:		80%	Invasive Coverage:		None
Neighbors:		Auto shop, adjacent vacant lot (1414 Gardner), baseball field			
Notes/ Comments:		Combined w/1414 makes ideal for neighborhood activity

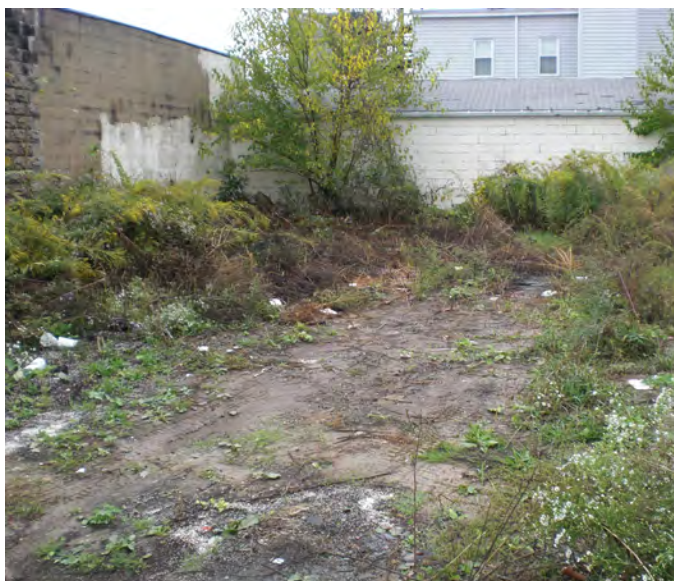
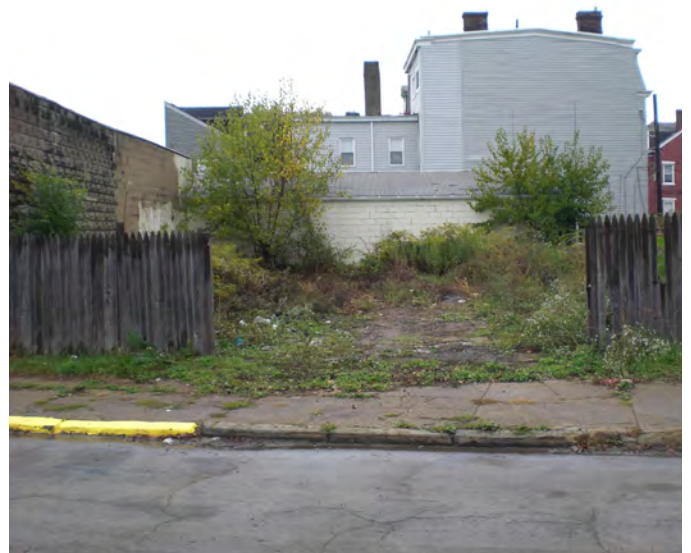
Owner: Pamela B. Dumont		Lot/Block #: 24-D-116	Address: 1414 Gardner
Summary of site condition:	Easily accessible, flat site with good sun exposure. Compaction is not a problem. Invasives and litter can be easily addressed. With owner permission, this site could provide an excellent, centrally located space for a community project.		
Organic Matter:	Good	Soil Contamination:	Low lead
Soil Structure:	Sand/clay	Compaction:	4" – compacted/normal
Rubble Type: Percentage:	Stone/brick on the surface	Dumping (1-10):	3 – low/medium
		Littering (1-10):	8 - high
Slope (1-10):	1 – none/slight	% Sun:	90%
		Canopy:	Neighboring buildings
Vegetation Coverage:	80%	Invasive Coverage:	<5% single <i>Ailanthus altissima</i> (tree of heaven)
Neighbors:	Auto shop, adjacent vacant lot (1412 Gardner), baseball field		
Notes/ Comments:	Combined w/1412 makes ideal for neighborhood activity

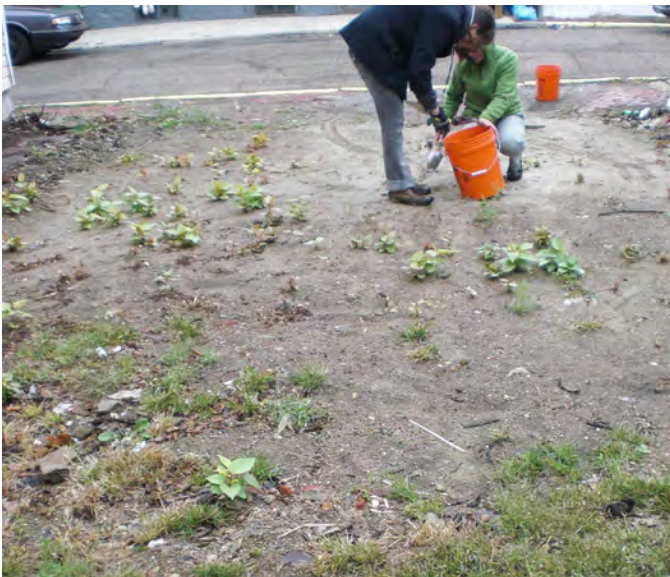
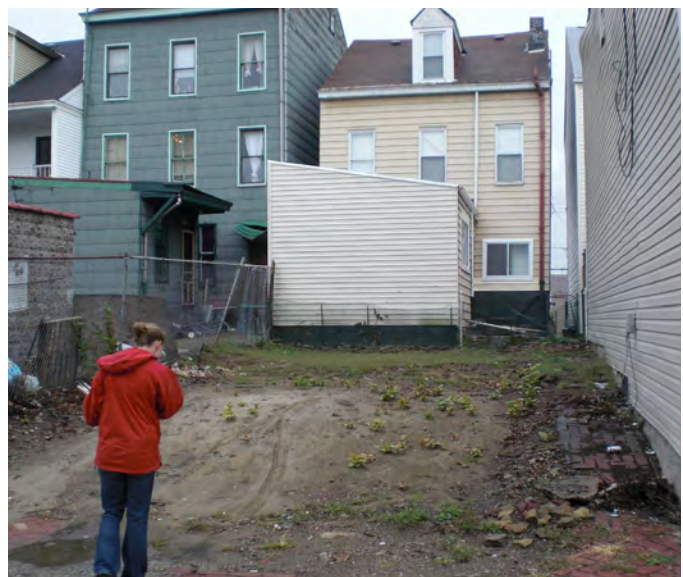
Owner: Mary Frances Virginia		Lot/Block #: 24-F-366	Address: 1119 Brabec
Summary of site condition:	A small infill lot with significant amounts of Japanese knotweed growing on it. This site has poor sun exposure and would most readily lend itself to a privately owned parking spot.		
Organic Matter:	Good	Soil Contamination:	Medium lead
Soil Structure:	Clay w/ sand capping front	Compaction:	4 – compacted/normal
Rubble Type:	Brick/gravel	Dumping (1-10):	1 – none/low
Percentage:	10%/5%	Littering (1-10):	4 - medium
Slope (1-10):	2 - slight	% Sun:	60%
		Canopy:	Neighboring buildings
Vegetation Coverage:	40%	Invasive Coverage:	50% <i>Fallopia japonica</i> (japanese knotweed)
Neighbors:	Garage with garbage overflowing, residential		
Notes/ Comments:	Sign that reads “posted private property,” may be for neighboring property. Was purchased in 2010 by current owner.

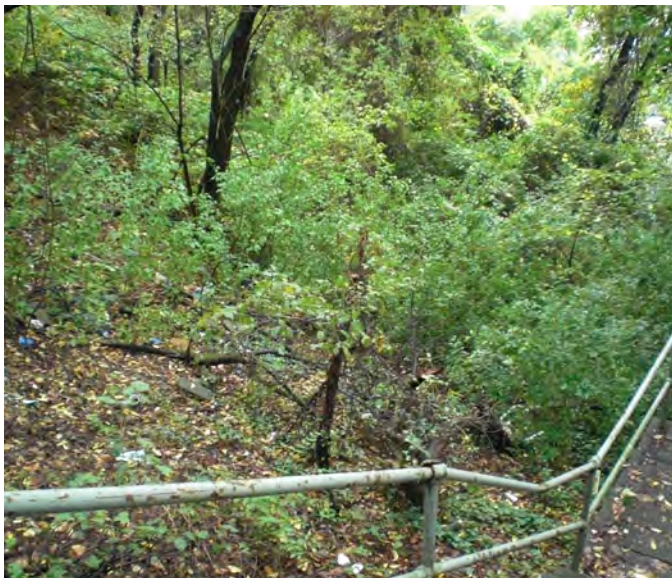
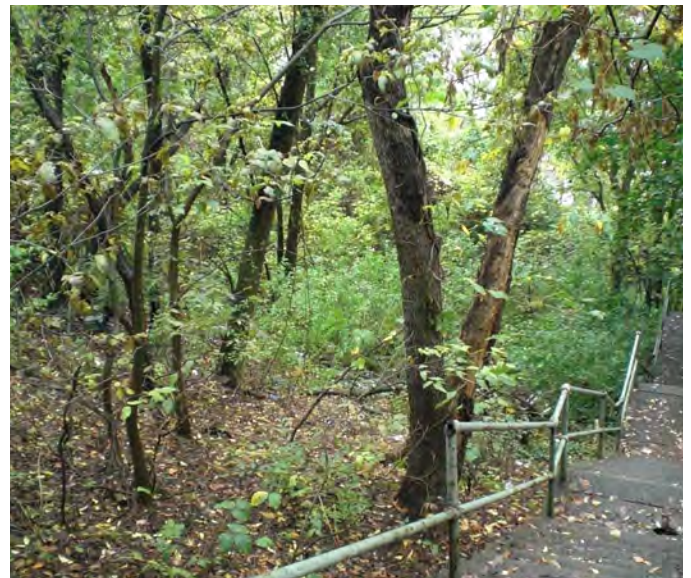
Owner: City of Pittsburgh		Lot/Block #: 24-G-98		Address: 1153 Bohemian	
Summary of site condition:		The site is situated on a heavily wooded hillside adjacent to a pedestrian staircase. The site experiences problematic dumping and littering. This site would not provide a good platform for greening projects but may be a good site for a neighborhood cleanup.			
Organic Matter:		Not tested		Soil Contamination:	
Soil Structure:		Loam		Compaction:	
Rubble Type:		None		Dumping (1-10):	
Percentage:		N/A		Littering (1-10):	
Slope (1-10):		7 – steep		% Sun:	
				Canopy:	
Vegetation Coverage:		100%		Invasive Coverage:	
Neighbors:		Wooded lots/residential			
Notes/ Comments:		Possible site for Allegheny CleanWays and/or Greenway status

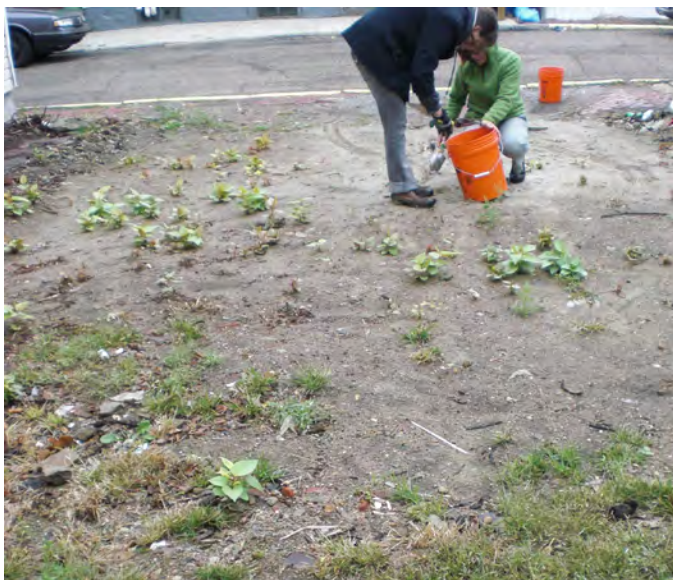
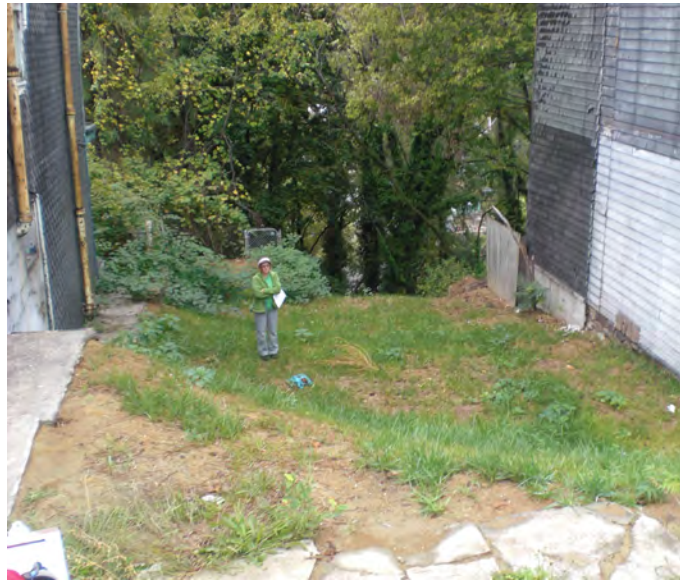
Owner: David A. Duncan		Lot/Block #: 24-G-101		Address: 1128 Brabec	
Summary of site condition:		A tricky site with steep slopes in the front and the back. There is a significant amount of Japanese knotweed in the back that may become a problem if not addressed. Most appropriate for a privately owned side yard.			
Organic Matter:		Low	Soil Contamination:		Low lead
Soil Structure:		Clay	Compaction:		7 – normal
Rubble Type:		2%	Dumping (1-10):		5 – medium
Percentage:		Brick	Littering (1-10):		2 – low
Slope (1-10):		10 front/ 2 mid	% Sun:		75%
			Canopy:		Buildings
Vegetation Coverage:		90%	Invasive Coverage:		10% <i>Fallopia japonica</i> (Japanese knotweed)
Neighbors:		Residential			
Notes/ Comments:		Rear hillside is very steep.

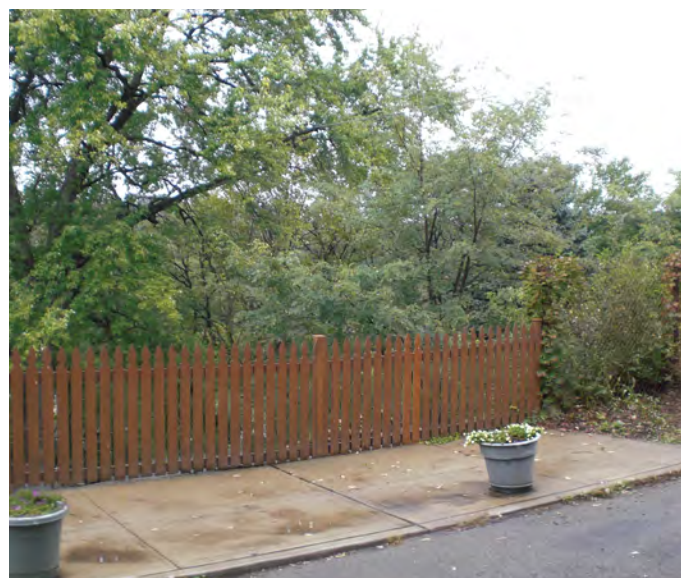
Owner: City of Pittsburgh		Lot/Block #: 24-G-119		Address: Lowrie			
Summary of site condition:		This site is currently being maintained as a side lot and the transfer of ownership should be facilitated.					
Organic Matter:		Not tested		Soil Contamination:		Not tested	
Soil Structure:		N/A		Compaction:		N/A	
Rubble Type:		None visible		Dumping (1-10):		1 – none/low	
Percentage:		N/A		Littering (1-10):		1 – none/low	
Slope (1-10):		8/3 – steep slope giving way to slight slope		% Sun:		50%	
				Canopy:		Buildings/trees	
Vegetation Coverage:		80%		Invasive Coverage:		None visible	
Neighbors:		Residential					
Notes/ Comments:		Currently being maintained as a side lot

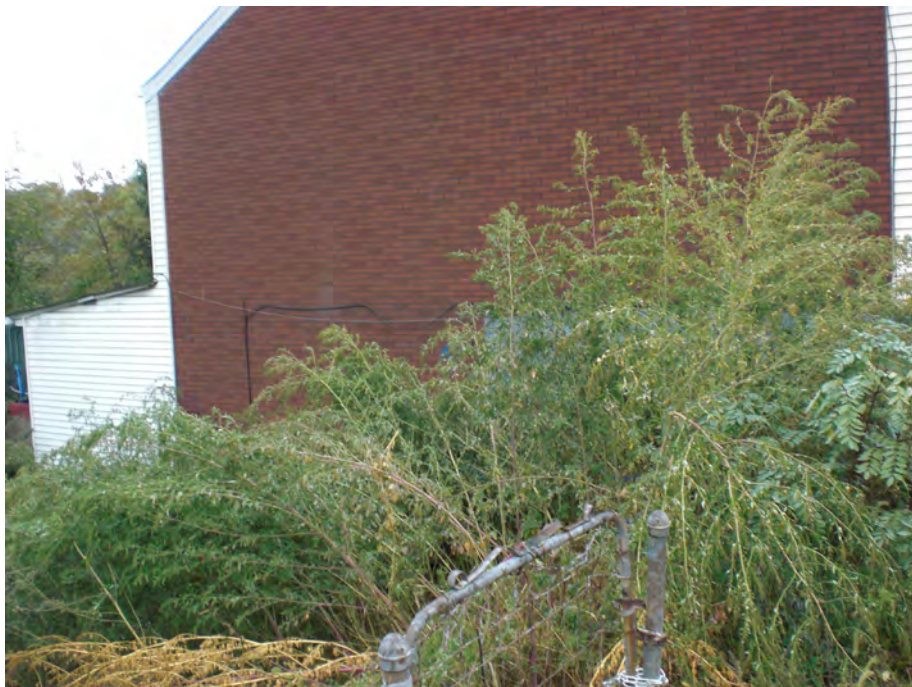
Owner: James Rosenberger		Lot/Block #: 24-G-122		Address: 1318 Lowrie	
Summary of site condition:		A sloping site with good conditions for plant growth. The site is densely covered with weeds but could be maintained as a side yard, or it could, in combination with adjacent lots provide a reasonable amount of space for a community project.			
Organic Matter:		Good		Soil Contamination: Medium lead	
Soil Structure:		Clay/loam		Compaction: 11 – soft	
Rubble Type:		Concrete		Dumping (1-10): 1 – none/low	
Percentage:		15%		Littering (1-10): 1 – none/low	
Slope (1-10):		8 /3 steep slope in the front giving way to a slight slope in the back		% Sun: 70%	
				Canopy: Buildings	
Vegetation Coverage:		100%		Invasive Coverage: 3% <i>Fallopia japonica</i> (japanese knotweed)	
Neighbors:		Residential, dog nearby			
Notes/ Comments:		Overgrown

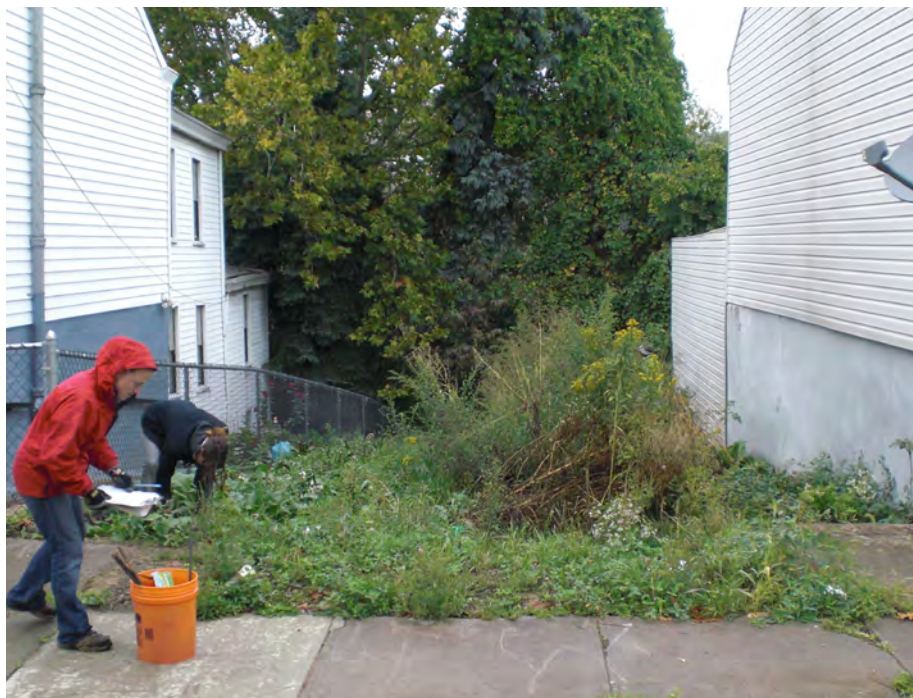
Owner: Edward C. & Robert J. Schell		Lot/Block #: 24-G-130		Address: 1336 Lowrie	
Summary of site condition:		A very nice site with a good possibility of being a side yard for one of the neighbors. Some Japanese knotweed in the rear of the site, but otherwise ideal.			
Organic Matter:	Good		Soil Contamination:	Medium lead	
Soil Structure:	Sand/clay loam		Compaction:	3 - compacted	
Rubble Type:	Sidewalk, gravel		Dumping (1-10):	1 – none/low	
Percentage:	10%		Littering (1-10):	2 – low	
Slope (1-10):	5 – moderate		% Sun:	75%	
			Canopy:	Buildings	
Vegetation Coverage:	100%		Invasive Coverage:	3% <i>Fallopia japonica</i> (japanese knotweed)	
Neighbors:	Residential				
Notes/ Comments:	Fence edge maintained

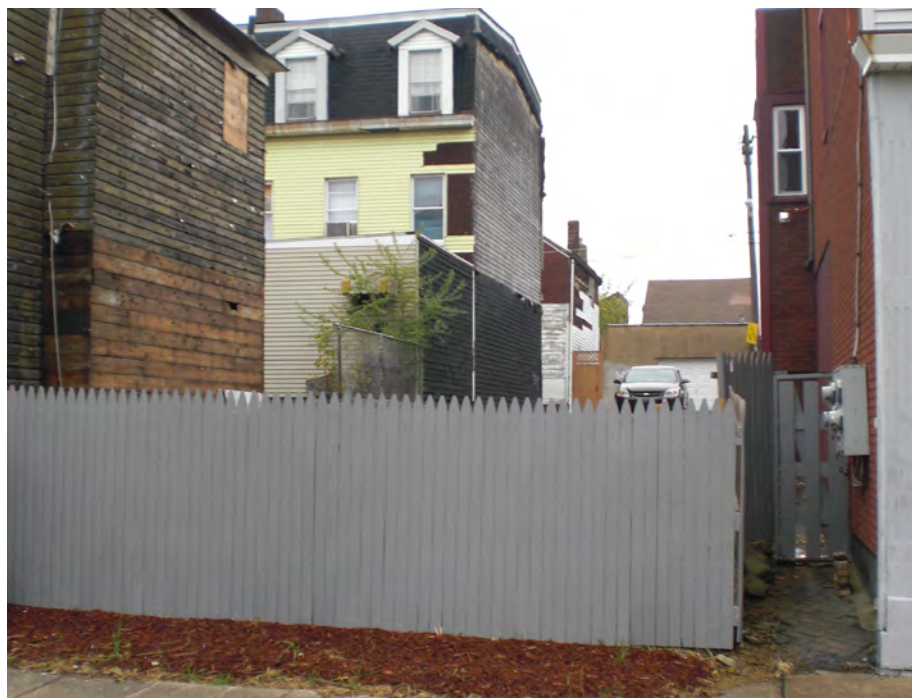
Owner: City of Pittsburgh		Lot/Block #: 24-G-145		Address: 1321 Lowrie	
Summary of site condition:		Site was apparently being cared for by neighboring house with a newly erected fence. Side lot sale should be facilitated.			
Organic Matter:		Did not sample		Soil Contamination:	
Soil Structure:		N/A		Compaction:	
Rubble Type:		N/A		Dumping (1-10):	
Percentage:		N/A		Littering (1-10):	
Slope (1-10):		N/A		% Sun:	
				Canopy:	
Vegetation Coverage:		N/A		Invasive Coverage:	
Neighbors:		Residential			
Notes/ Comments:		New fence, cared for as side lot

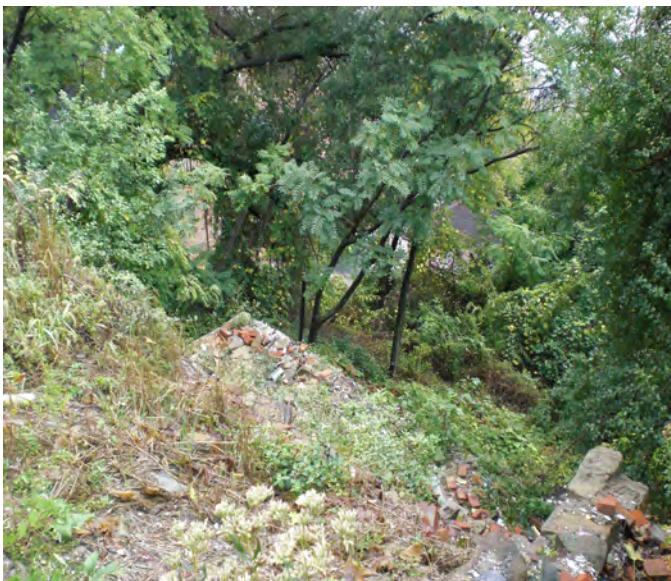
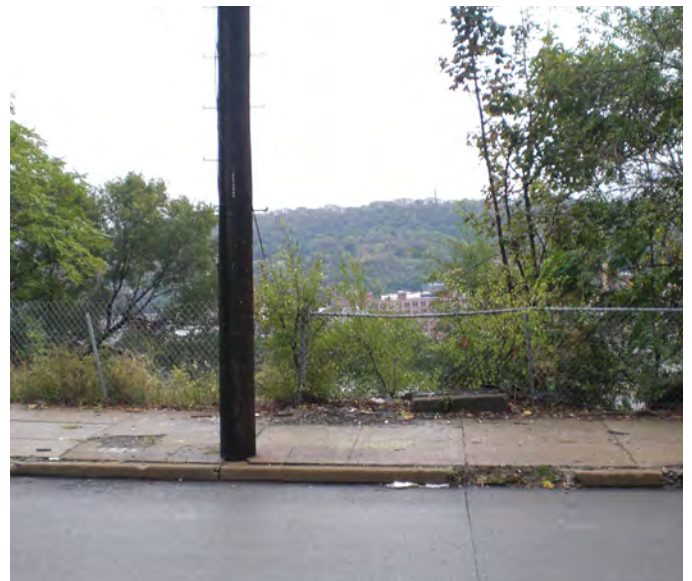
Owner: City of Pittsburgh		Lot/Block #: 24-G-322		Address: 1321 Troy Hill	
Summary of site condition:		This lot is an extremely steep slope with no neighbors nearby. It is extremely rubble-filled and would not be a practical site for community greening efforts.			
Organic Matter:	Did not sample	Soil Contamination:	Did not sample		
Soil Structure:	N/A	Compaction:	N/A		
Rubble Type:	Brick/stone	Dumping (1-10):	2 – low		
Percentage:	90%	Littering (1-10):	6 – medium		
Slope (1-10):	10 – very steep/dangerous	% Sun:	80%		
		Canopy:	Trees		
Vegetation Coverage:	80%	Invasive Coverage:	5% <i>Ailanthus altissima</i> (tree of heaven)		
Neighbors:	None				
Notes/ Comments:	Rubble filled, extremely steep slope. Consider Greenway status.

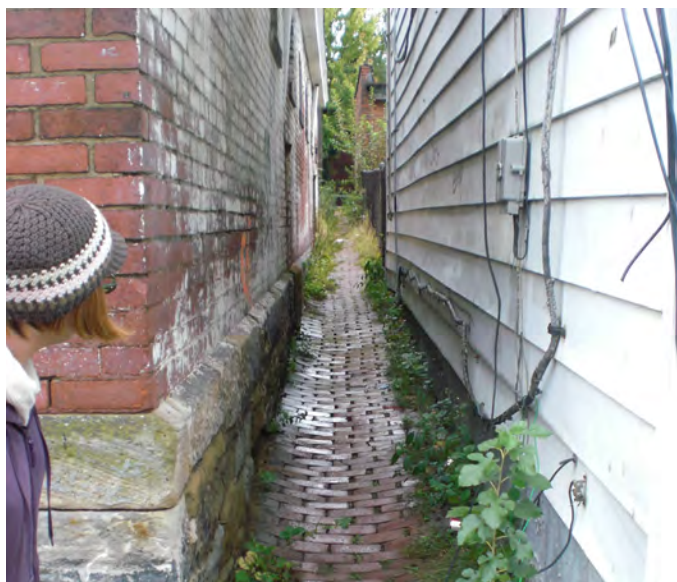
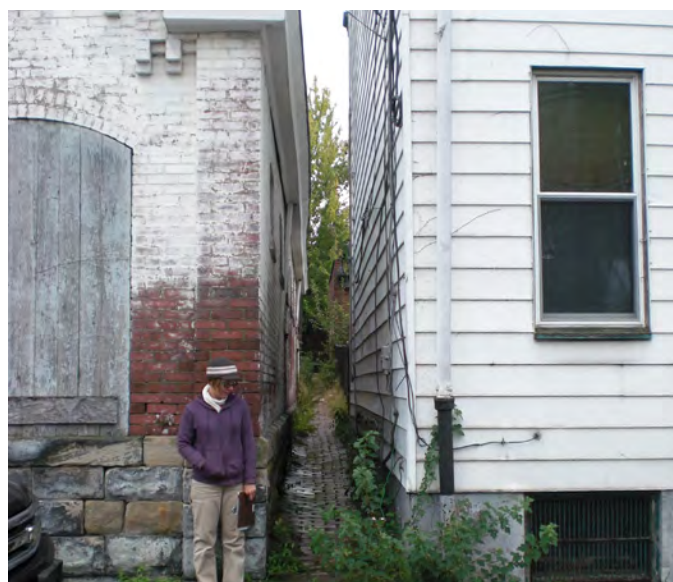
Owner: City of Pittsburgh	Lot/Block #: 24-H-010	Address: Traux
Summary of site condition:	This site is a brick walkway that connects Traux Way to Lowrie Street. The lot is for sale by the city.	
Organic Matter:	N/A	Soil Contamination: N/A
Soil Structure:	N/A	Compaction: N/A
Rubble Type:	None	Dumping (1-10): 1 – none/low
Percentage:	N/A	Littering (1-10): 2 – low
Slope (1-10):	1 – none/slight	% Sun: 30%
		Canopy: Buildings
Vegetation Coverage:	30%	Invasive Coverage: None
Neighbors:	Residential, school	
Notes/ Comments:	Brick walkway

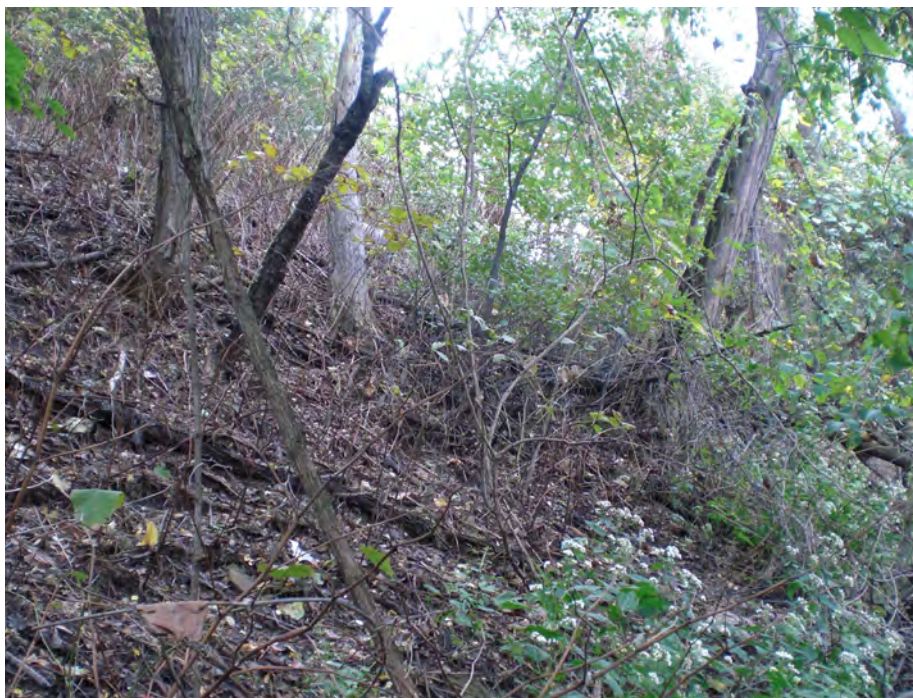
Owner: City of Pittsburgh		Lot/Block #: 47-S-171		Address: Harpster	
Summary of site condition:		Heavily wooded hillside with little dumping or littering. Japanese knotweed is pervasive under the canopy, but maintaining vegetation will reduce any erosion.			
Organic Matter:		High	Soil Contamination:		Medium lead
Soil Structure:		Silt loam	Compaction:		9 –normal/soft
Rubble Type:		None	Dumping (1-10):		2 – low
Percentage:		N/A	Littering (1-10):		1 – none/low
Slope (1-10):		9 – very steep (NW Facing)	% Sun:		10%
			Canopy:		Large trees
Vegetation Coverage:		Forested with understory	Invasive Coverage:		50% <i>Fallopia japonica</i> (japanese knotweed)
Neighbors:		Industrial (Branded Solution)			
Notes/ Comments:		Layer of duff removed for soil testing. Consider pursuing Greenway status.

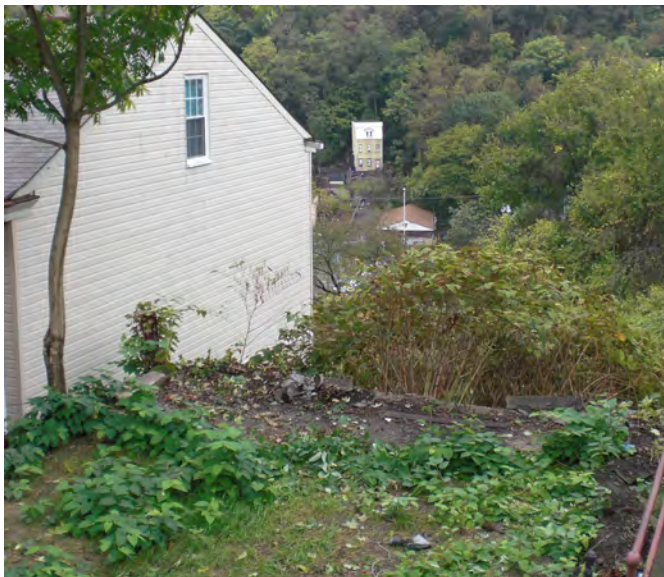
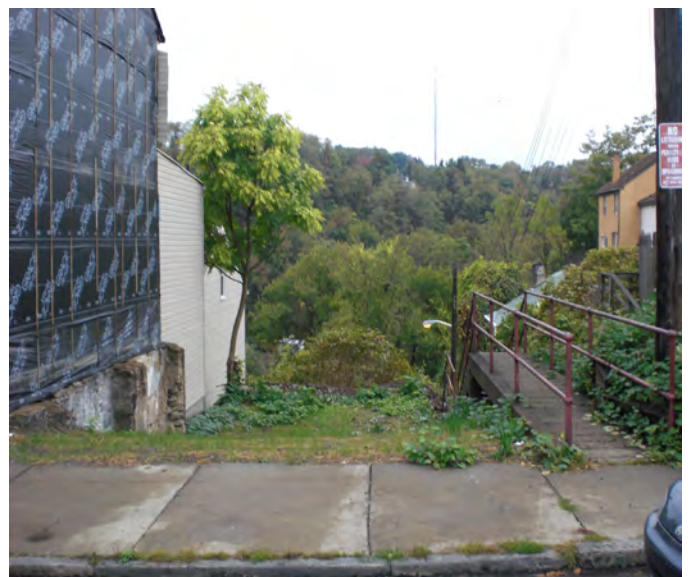
Owner: City of Pittsburgh		Lot/Block #: 47-S-184		Address: 1606 Hatteras	
Summary of site condition:		A small slope in the front flattens out to a nice space directly adjacent to a public staircase. The site is across the street from the park on Hatteras and Claim and may make a nice site for a community project. Cleanup is needed next to the stairway.			
Organic Matter:		Low		Soil Contamination:	
Soil Structure:		Gravel, clay		Compaction:	
Rubble Type:		None		Dumping (1-10):	
Percentage:		N/A		Littering (1-10):	
Slope (1-10):		7/1 steep slope giving way to no/slight slope in the back		% Sun:	
				Canopy:	
Vegetation Coverage:		50%		Invasive Coverage:	
				10% <i>A. altissima</i> (tree of heaven), <i>F. japonica</i> (japanese knotweed)	
Neighbors:		Residential and a pedestrian staircase			
Notes/ Comments:		Newly graded and seeded w/ grass, adjacent lot suffers from severe dumping and littering

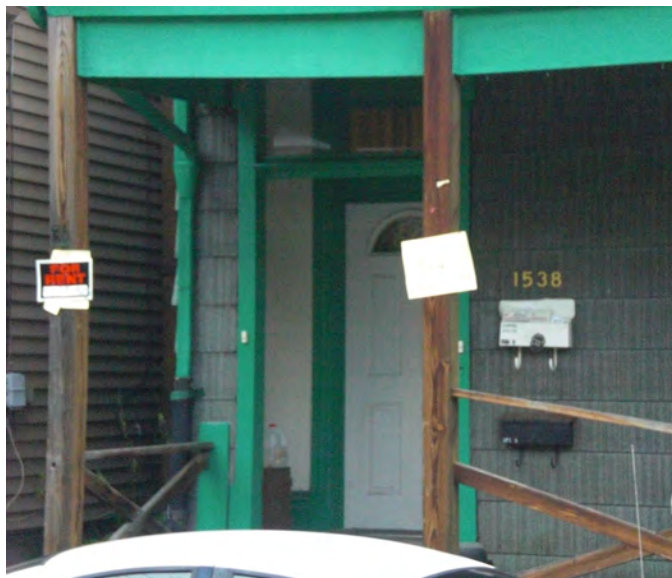
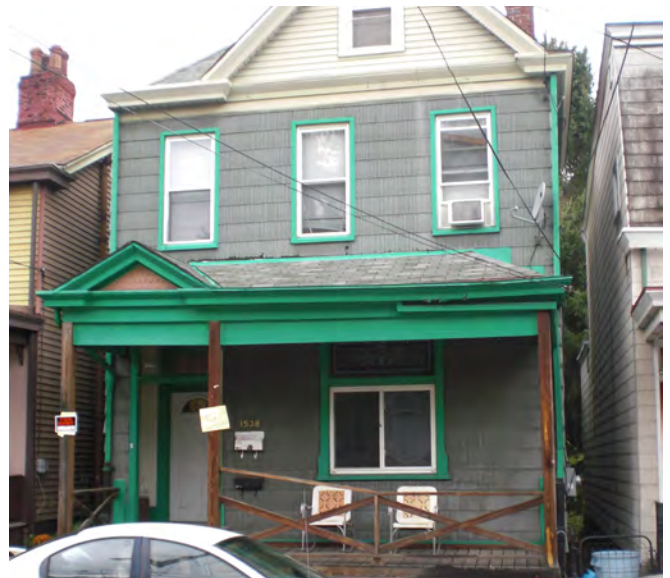
Owner: Antonio Veneziano		Lot/Block #: 47-S-194		Address: 1538 Hatteras	
Summary of site condition:		There is currently a structure on the site with a sign that states “For Rent.”			
Organic Matter:	Did not sample		Soil Contamination:	Did not sample	
Soil Structure:	N/A		Compaction:	N/A	
Rubble Type:	N/A		Dumping (1-10):	N/A	
Percentage:	N/A		Littering (1-10):	N/A	
Slope (1-10):	N/A		% Sun:	N/A	
			Canopy:	N/A	
Vegetation Coverage:	N/A		Invasive Coverage:	N/A	
Neighbors:	Residential				
Notes/ Comments:	Structure "For Rent" 412-818-5868

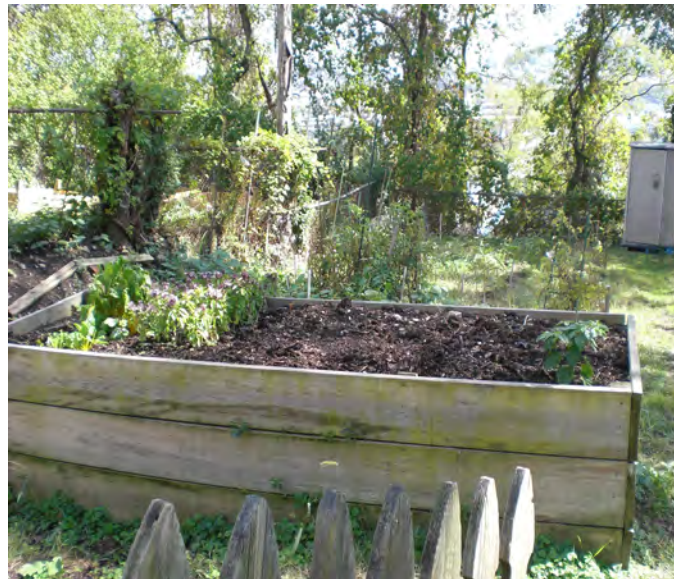
Owner: City of Pittsburgh		Lot/Block #: 47-S-290-A		Address: 1714 Hatteras Rear	
Summary of site condition:		The lot is effectively the backyard of 1714 Hatteras and side lot purchase should be facilitated.			
Organic Matter:		Did not sample		Soil Contamination:	
				Did not sample	
Soil Structure:		N/A		Compaction:	
				N/A	
Rubble Type:		N/A		Dumping (1-10):	
Percentage:		N/A		Littering (1-10):	
				N/A	
Slope (1-10):		N/A		% Sun:	
				Canopy:	
				N/A	
Vegetation Coverage:		N/A		Invasive Coverage:	
				N/A	
Neighbors:		Residential			
Notes/ Comments:		Lot is located in the rear of an existing house, property lines unclear.

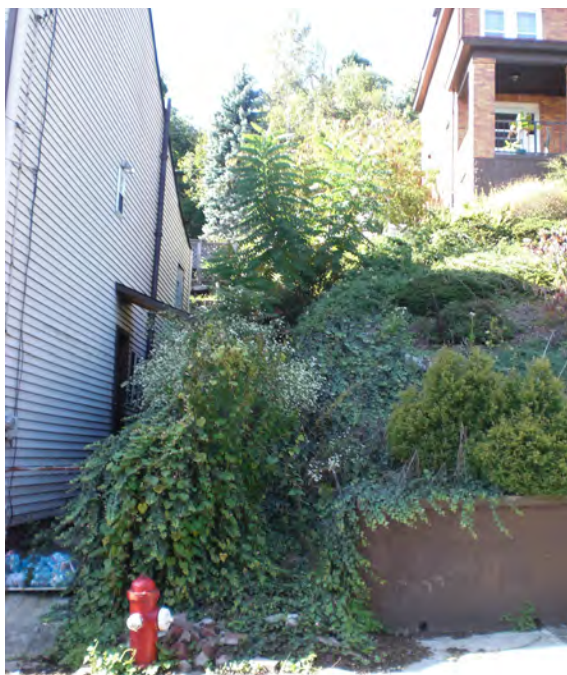
Owner: City of Pittsburgh		Lot/Block #: 48-A-267		Address: 2130 Straubs	
Summary of site condition:		The lot is a sliver of land between two residential properties. It has the potential to be a side lot sale if it is not considered a right of way.			
Organic Matter:		Did not sample		Soil Contamination:	
Soil Structure:		N/A		Compaction:	
Rubble Type:		Brick		Dumping (1-10):	
Percentage:		Unclear		Littering (1-10):	
Slope (1-10):		8 – steep		% Sun:	
				Canopy:	
Vegetation Coverage:		100%		Invasive Coverage:	
Neighbors:		Residential			
Notes/ Comments:		Possible walkway/right-of-way for utilities. Possible side yard, needs to be cleared out.

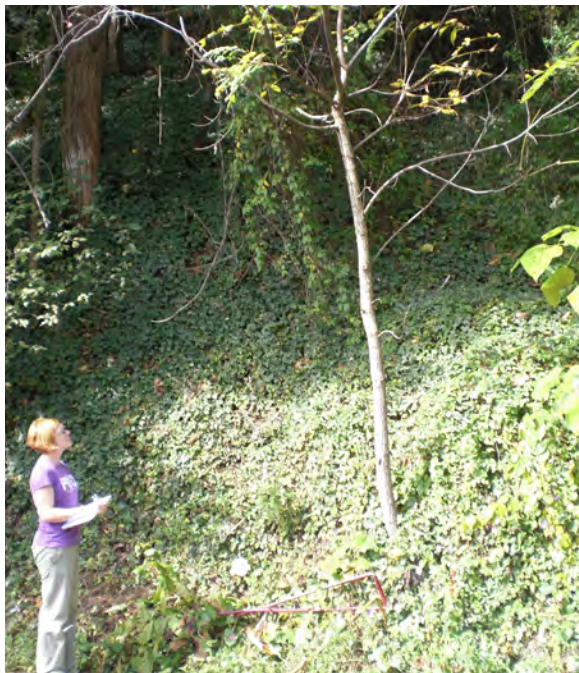
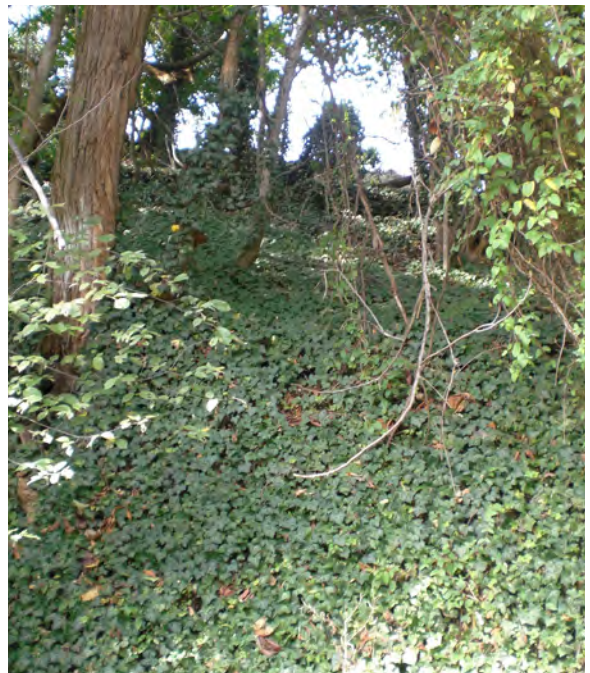
Owner: City of Pittsburgh		Lot/Block #: 48-B-5		Address: 2156 Liedertafel	
Summary of site condition:		This site is a wooded lot on a steep slope. It would not be a practical choice for a community greening project.			
Organic Matter:		Did not sample		Soil Contamination:	
Soil Structure:		N/A		Compaction:	
Rubble Type:		None visible		Dumping (1-10):	
Percentage:		N/A		Littering (1-10):	
Slope (1-10):		9 – very steep		% Sun:	
				Canopy:	
Vegetation Coverage:		100%		Invasive Coverage:	
Neighbors:		Wooded lots, residential			
Notes/ Comments:		Steep hill, forested with heavy ivy

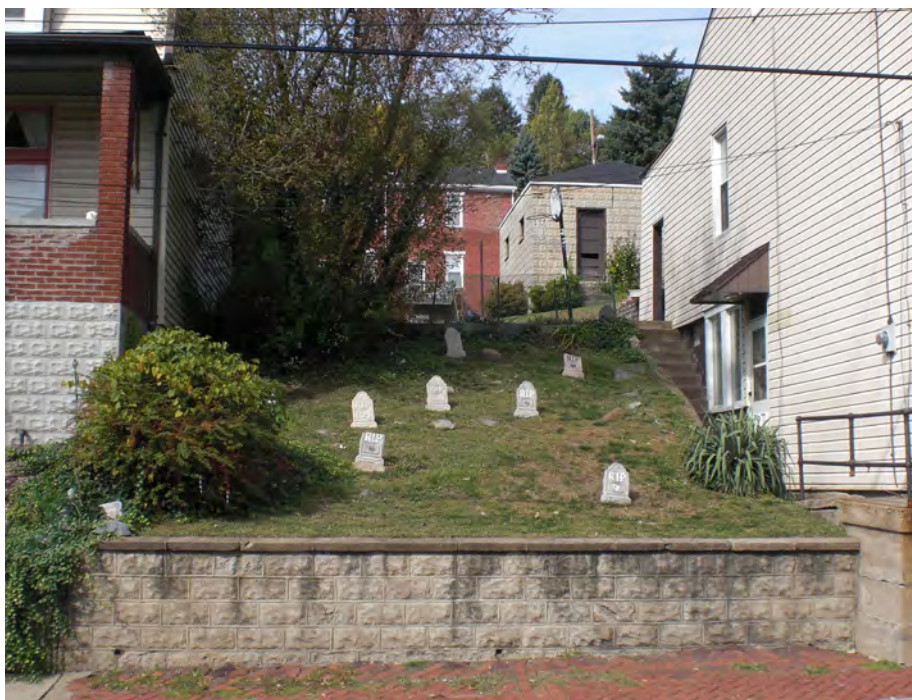
Owner: Chmura Living Trust		Lot/Block #: 48-B-131		Address: 2128 Lowrie	
Summary of site condition:		Side yard of neighboring house. Is well maintained and not in need of additional work.			
Organic Matter:		Did not sample		Soil Contamination:	
Soil Structure:		N/A		Compaction:	
Rubble Type:		50%		Dumping (1-10):	
Percentage:		Stone		Littering (1-10):	
Slope (1-10):		6 – moderate		% Sun:	
				Canopy:	
Vegetation Coverage:		100% grass/ornamentals		Invasive Coverage:	
Neighbors:		Residential			
Notes/Comments:		Occupied & cared for, picture below includes Halloween decorations.

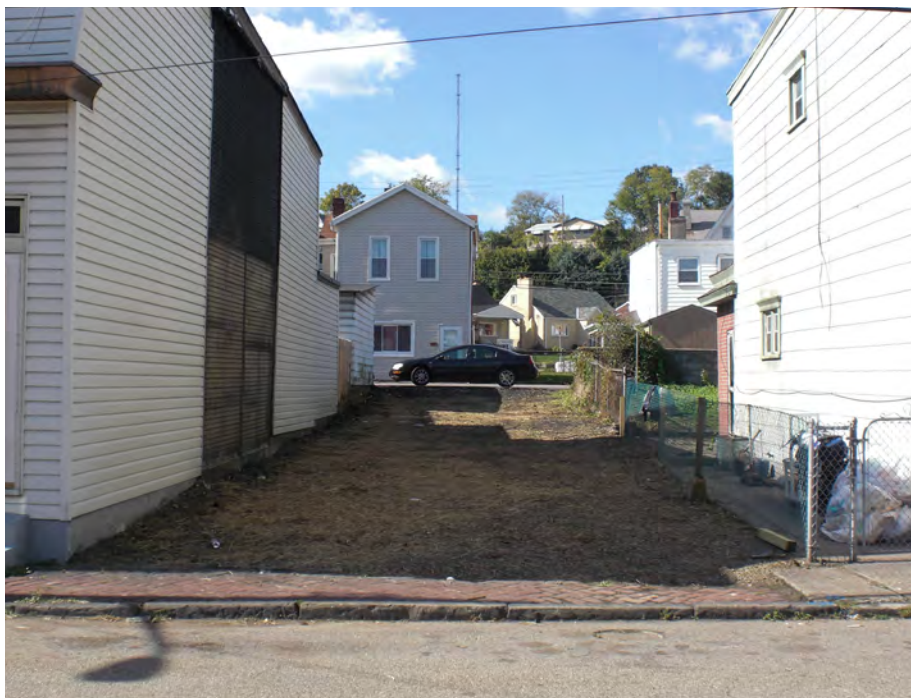
Owner: Glenn J. Wack		Lot/Block #: 48-E-216		Address: 1950 Ley	
Summary of site condition:		A recent demo, this site has little vegetation whatsoever. This infill lot may be well suited as a green space with a walkway to provide access between Ley St. and Tours Way.			
Organic Matter:	Good	Soil Contamination:	Medium lead		
Soil Structure:	Gravel fill	Compaction:	6 – normal		
Rubble Type:	Stone	Dumping (1-10):	1 – none/low		
Percentage:	<5%	Littering (1-10):	1 – none/low		
Slope (1-10):	2 – low	% Sun:	40%		
		Canopy:	Buildings		
Vegetation Coverage:	<5%	Invasive Coverage:	None		
Neighbors:	Residence				
Notes/ Comments:	Large dog next door
