# TROY HILL VACANT

## TROY HILL, PITTSBURGH 2011

# LAND ASSESSMENT

This 2011 report was produced by GTECH Strategies (Growth Through Energy and Community Health) for the Troy Hill Citizens Inc. This plan was financed with a grant from the City of Pittsburgh through the Community Development Block Grant (CDBG) Program, Luke Ravenstahl, Mayor.

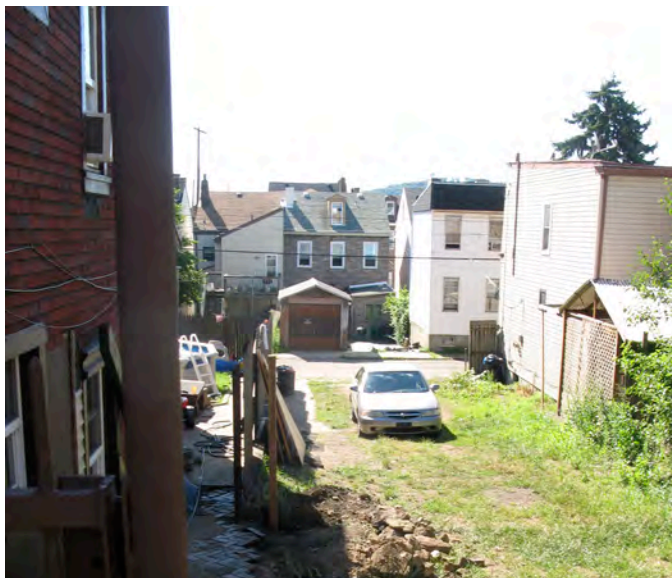
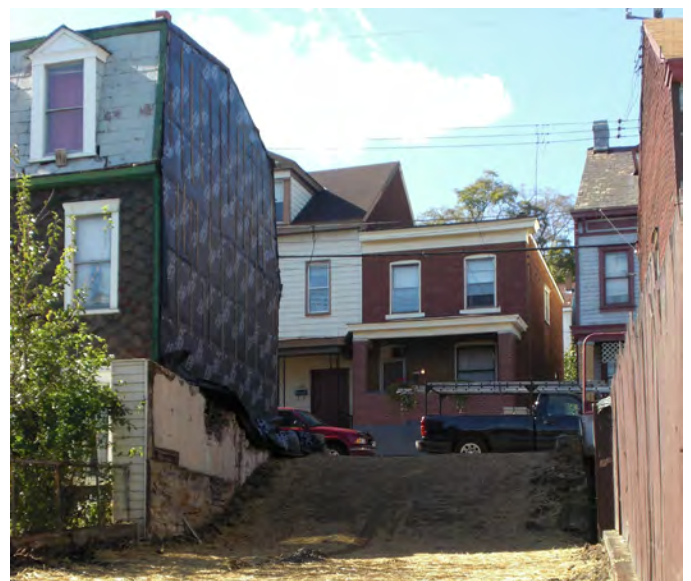
Owner: G8 Capital LLC.		Lot/Block #: 48-E-258		Address: 2038 Ley 2039 Straubs	
Summary of site condition:		A recent demo, this site has little vegetation whatsoever. This infill lot may be well suited as a green space with a walkway to provide access between Straubs Ln. and Ley St.			
Organic Matter:		Good		Soil Contamination:	
Soil Structure:		Clay/gravel		Compaction:	
Rubble Type:		Stone		Dumping (1-10):	
Percentage:		12%		Littering (1-10):	
Slope (1-10):		8/3 – steep slope down from Straubs giving way to a slight slope		% Sun:	
Vegetation Coverage:		20%		Canopy:	
Neighbors:		Residential			
Notes/ Comments:		Severe compaction, neighbor, Melissa Tutro interested in purchase as side yard. Current owner purchased the site late in 2010.

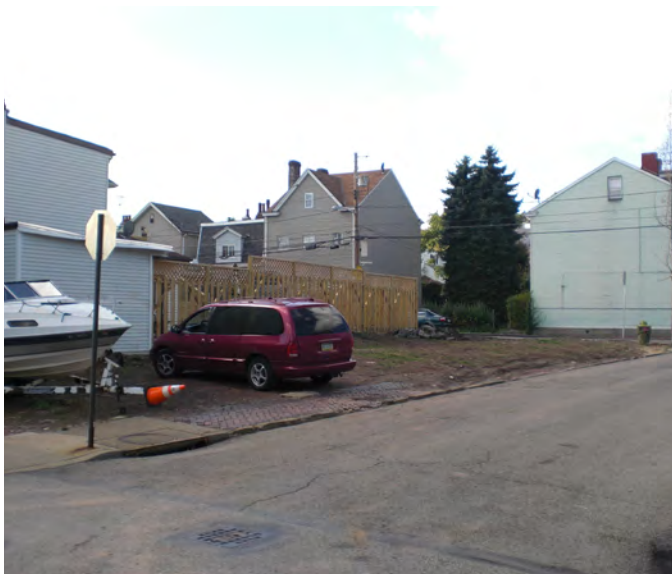
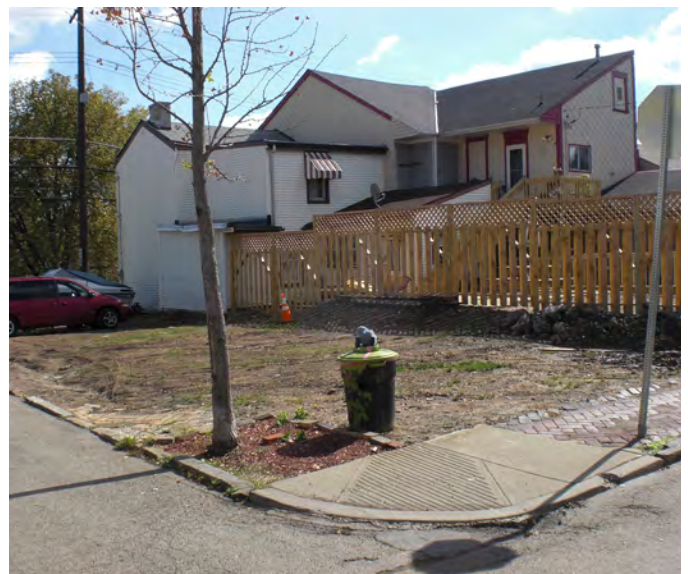
Owner: Project Delivery LLC.		Lot/Block #: 48-E-310		Address: 1809 Niggel 1966 Lowrie	
Summary of site condition:		A muddy strip of land at the end of a block, this site is adjacent to a restaurant/bar which may be best used as parking.			
Organic Matter:		Low	Soil Contamination:		Low lead
Soil Structure:		Clay	Compaction:		3 – compacted
Rubble Type:		Brick, concrete, stone	Dumping (1-10):		1 – none/low
Percentage:		20%	Littering (1-10):		1 – none/low
Slope (1-10):		1 – none/slight	% Sun:		85%
			Canopy:		Buildings
Vegetation Coverage:		10%	Invasive Coverage:		<5% <i>Fallopia japonica</i> (japanese knotweed)
Neighbors:		Residential, bar, graveyard			
Notes/ Comments:		Currently being used as a parking lot, Jeffery Anesin (412-657-7557) says he applied for side lot purchase.

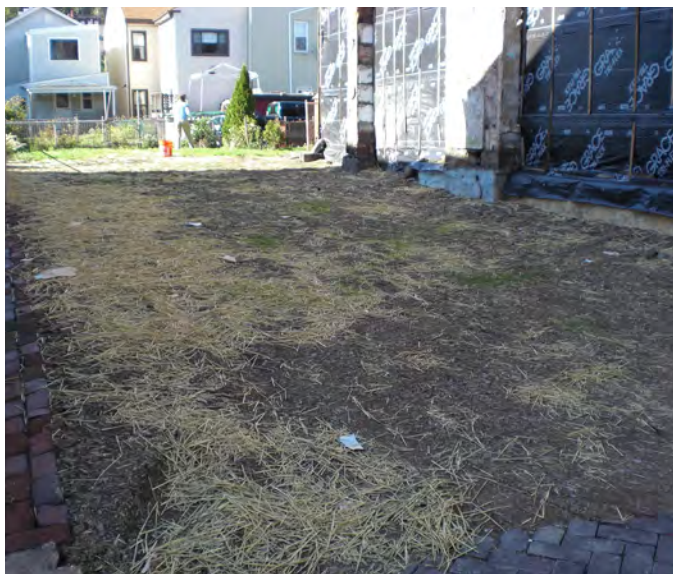
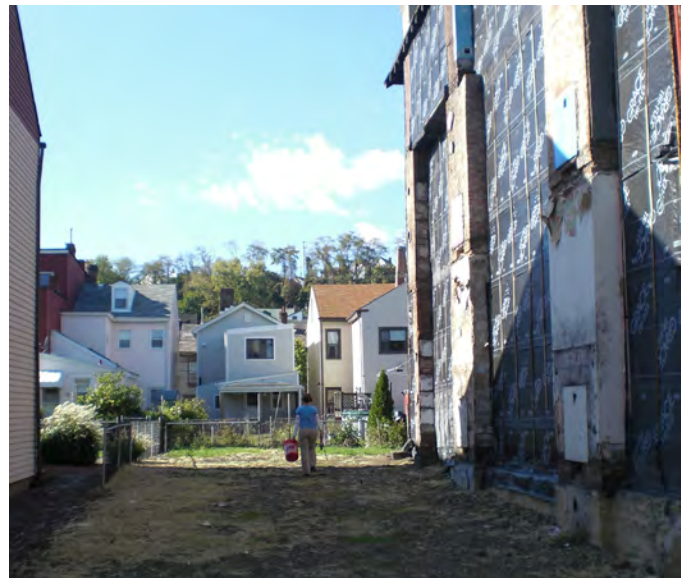
Owner: Mathew Mieczkowski		Lot/Block #: 48-E-354	Address: 2026 Lautner
Summary of site condition:	A recent demo, this site has little vegetation whatsoever. This flat infill lot is well suited to become a privately owned side yard.		
Organic Matter:	High	Soil Contamination:	Medium lead
Soil Structure:	Gravel, clay	Compaction:	5 – normal
Rubble Type: Percentage:	Brick/rock	Dumping (1-10):	1 – none/low
	<5%	Littering (1-10):	1 – none/low
Slope (1-10):	2 – slight	% Sun:	40% front, 70% rear
		Canopy:	Buildings
Vegetation Coverage:	15% rear (grass)	Invasive Coverage:	0%
Neighbors:	Residential		
Notes/ Comments:	Recent demo, possible side lot, gravel fill

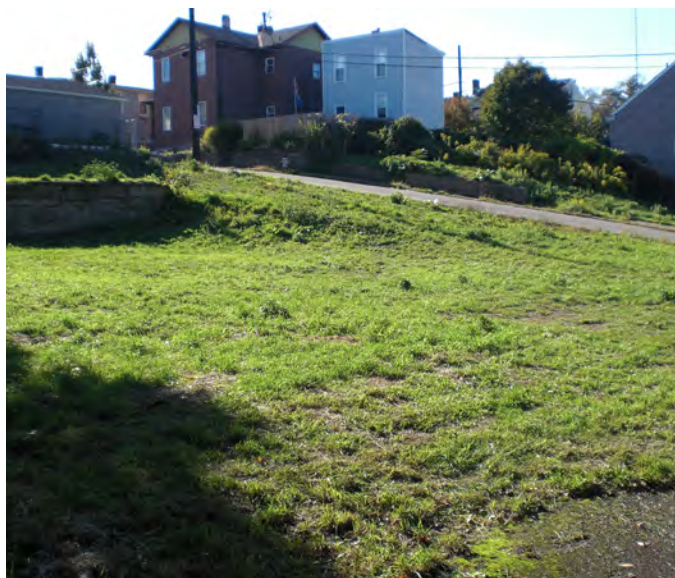
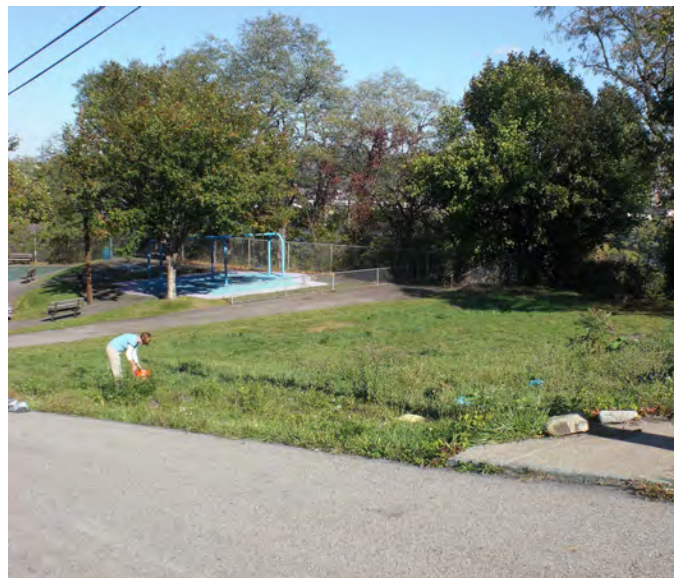
Owner: City of Pittsburgh		Lot/Block #: 48-F-138		Address: 1905 Lookout	
Summary of site condition:		A nice open site with good sun exposure and a great view. The tests for lead on this site came back high and the City will follow up by doing additional testing.			
Organic Matter:	High	Soil Contamination:	Extremely high lead and sulfur, more testing needed		
Soil Structure:	Gravel/clay loam	Compaction:	2 – very compacted		
Rubble Type:	Rock, concrete	Dumping (1-10):	1 – none/low		
Percentage:	15%	Littering (1-10):	2 – none/low		
Slope (1-10):	Variable 2/7/4	% Sun:	85%		
		Canopy:	Trees		
Vegetation Coverage:	100% (maintained grass)	Invasive Coverage:	3% <i>Ailanthus altissima</i> (tree of heaven)		
Neighbors:	Playground, residential				
Notes/ Comments:	Great location; overlook; adjacent to playground. City will do additional testing.

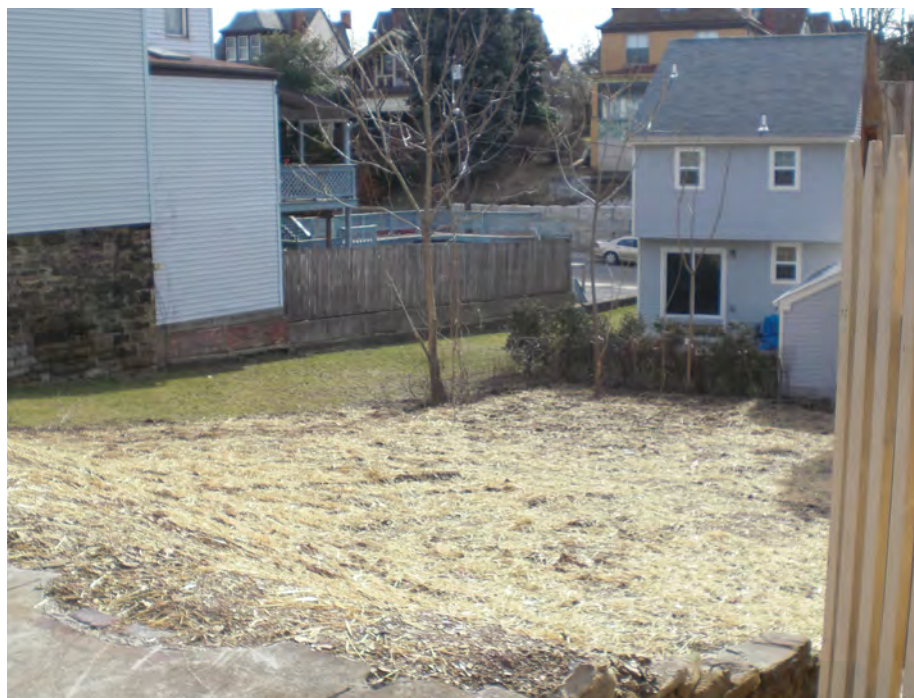
Owner: Pgh Central Federal Credit Union		Lot/Block #: 48-J-90		Address: 1803 Rialto	
Summary of site condition:		A recent demo, this lot in addition to the adjacent vacant lot is central in the neighborhood and high visibility. With a slight slope in the front this site is a good candidate for a community-based project.			
Organic Matter:	Did not sample		Soil Contamination:	Did not sample	
Soil Structure:	N/A		Compaction:	N/A	
Rubble Type:	N/A		Dumping (1-10):	N/A	
Percentage:	N/A		Littering (1-10):	N/A	
Slope (1-10):	N/A		% Sun:	N/A	
			Canopy:	N/A	
Vegetation Coverage:	N/A		Invasive Coverage:	N/A	
Neighbors:	Residential				
Notes/ Comments:	Recent demo, structures existed during initial site surveys

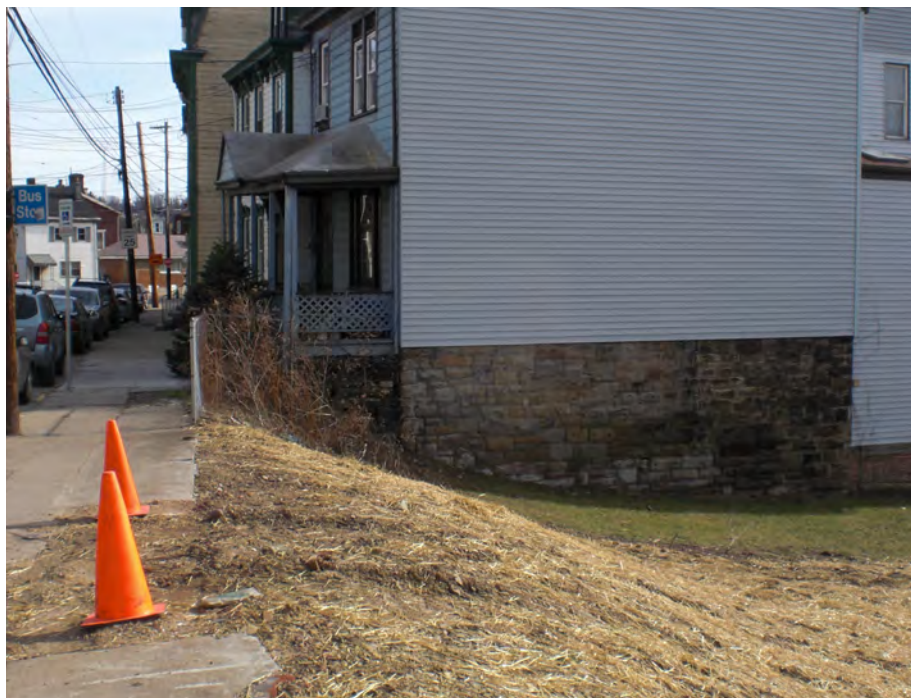
Owner: Robert J. Katic		Lot/Block #: 48-J-91		Address: 1801 Rialto	
Summary of site condition:		A recent demo, this lot in addition to the adjacent vacant lot is central in the neighborhood and high visibility. With a slight slope in the front this site is a good candidate for a community-based project.			
Organic Matter:	Did not sample		Soil Contamination:	Did not sample	
Soil Structure:	N/A		Compaction:	N/A	
Rubble Type:	N/A		Dumping (1-10):	N/A	
Percentage:	N/A		Littering (1-10):	N/A	
Slope (1-10):	N/A		% Sun:	N/A	
			Canopy:	N/A	
Vegetation Coverage:	N/A		Invasive Coverage:	N/A	
Neighbors:	Residential, adjacent vacant lot				
Notes/ Comments:	Recent demo, structures existed during initial site surveys

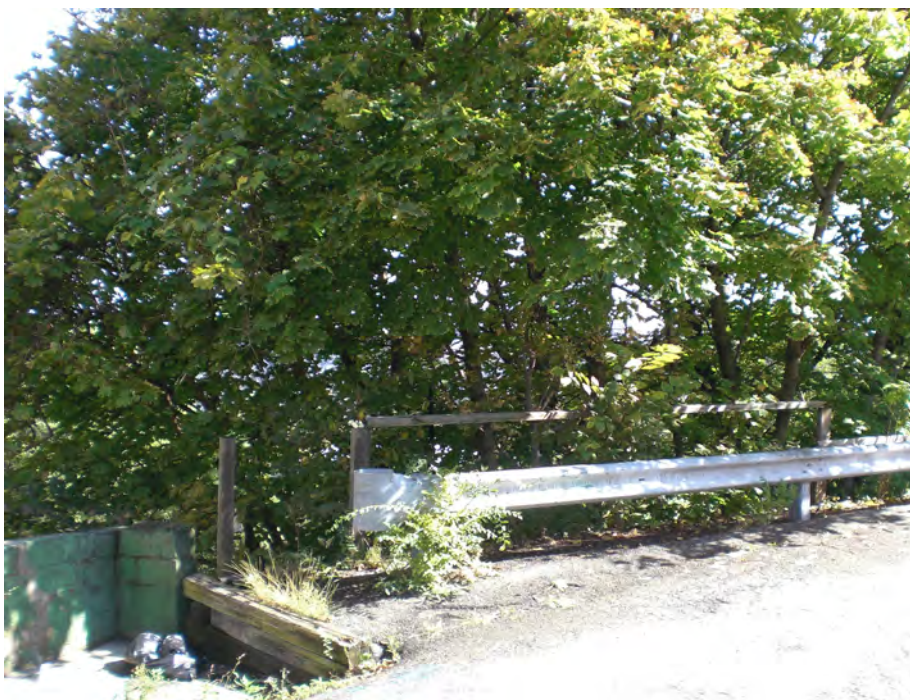
Owner: City of Pittsburgh	Lot/Block #: 48-J-315	Address: 1829 Elbow
Summary of site condition:	This site is on an extreme slope, which is wooded. It would not be a practical site for greening projects.	
Organic Matter:	Did not sample	Soil Contamination: Did not sample
Soil Structure:	N/A	Compaction: N/A
Rubble Type:	N/A	Dumping (1-10): 6 – medium
Percentage:	Unknown	Littering (1-10): 9 – high
Slope (1-10):	10 – very steep/dangerous	% Sun: <20%
		Canopy: Large trees
Vegetation Coverage:	100%	Invasive Coverage: 50% <i>Fallopia japonica</i> (japanese knotweed)
Neighbors:	Vacant lots, residential	
Notes/ Comments:	A group of several lots on an extreme hillside

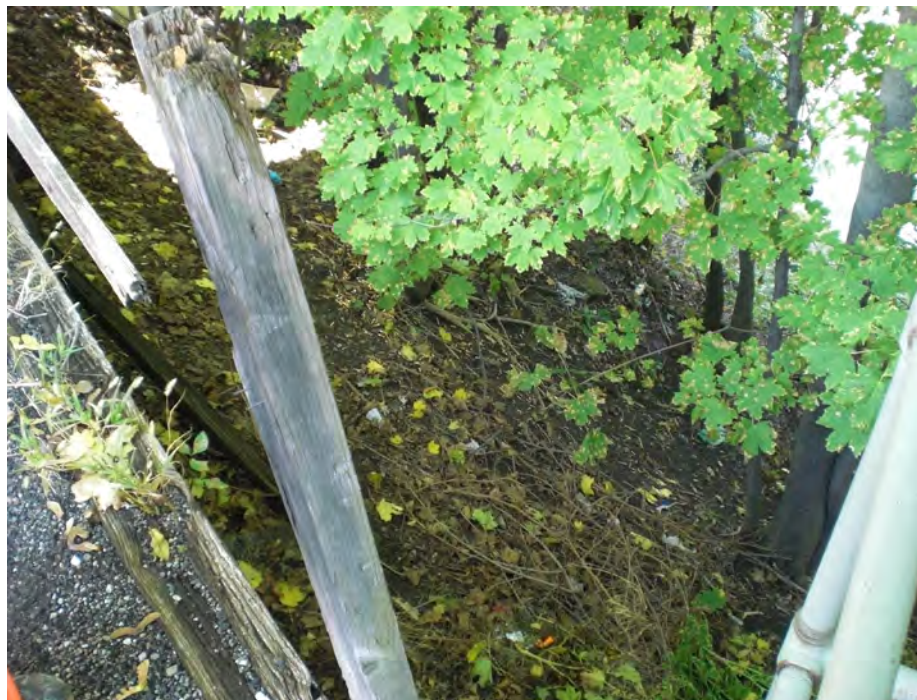
Owner: City of Pittsburgh		Lot/Block #: 48-J-321		Address: 1523 Rialto	
Summary of site condition:		This site is on an extreme slope, which is wooded and has high levels of invasives. It would not be a practical site for greening projects.			
Organic Matter:		Did not sample		Soil Contamination:	
Soil Structure:		N/A		Compaction:	
Rubble Type:		Demo		Dumping (1-10):	
Percentage:		Unknown		Littering (1-10):	
Slope (1-10):		9 – very steep		% Sun:	
				Canopy:	
Vegetation Coverage:		100%		Invasive Coverage:	
Neighbors:		Residential, roads			
Notes/ Comments:		A group of several lots on an extreme hillside

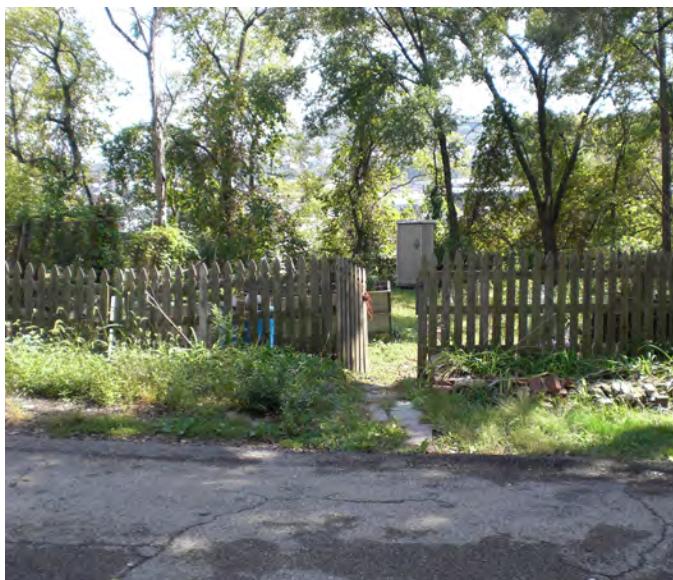
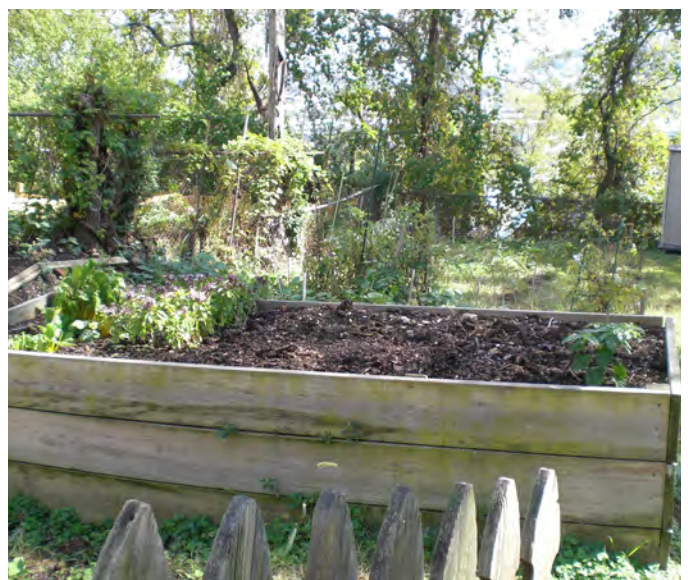
Owner: City of Pittsburgh		Lot/Block #: 48-N-100	Address: 1819 Elbow
Summary of site condition:	Site is currently a community garden. Nice site for garden could have trees selectively pruned/cut down to improve sun exposure.		
Organic Matter:	High	Soil Contamination:	Low lead
Soil Structure:	Clay loam	Compaction:	7 – normal
Rubble Type:	None	Dumping (1-10):	1 – none/low
Percentage:	N/A	Littering (1-10):	1 – none/low
Slope (1-10):	2 – slight	% Sun:	70%
		Canopy:	Trees
Vegetation Coverage:	<90%	Invasive Coverage:	<5% <i>Fallopia japonica</i> (japanese knotweed)
Neighbors:	Wooded lots, residential		
Notes/ Comments:	Community garden

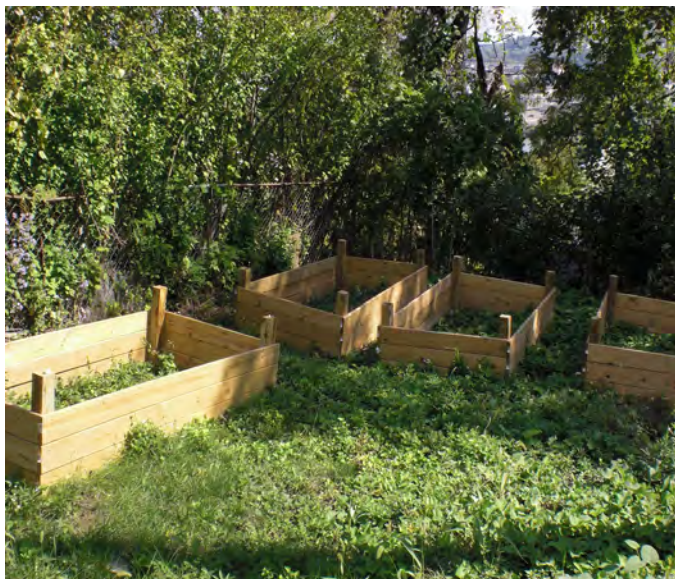
Owner: City of Pittsburgh		Lot/Block #: 48-N-101		Address: 1821 Elbow	
Summary of site condition:		Narrow site adjacent to the community garden. Some invasive weeds that need continued maintenance to be controlled. The tree canopy may need to be managed if this site is to become an expansion of the garden.			
Organic Matter:	Good	Soil Contamination:	Medium lead		
Soil Structure:	Clay loam	Compaction:	5 – normal		
Rubble Type:	Bricks, concrete	Dumping (1-10):	1 – none/low		
Percentage:	10%	Littering (1-10):	1 – none/low		
Slope (1-10):	2 – slight	% Sun:	70%		
		Canopy:	Trees		
Vegetation Coverage:	95%	Invasive Coverage:	60% <i>F. japonica</i> (japanese knotweed), <i>Ailanthus altissima</i> (tree of heaven)		
Neighbors:	Residential, community garden				
Notes/ Comments:	Possible community garden expansion
